# CONCRETE RETAINING BLOCK WALLS

FAILSAFE BUILDING MEASUREMENTS

## MOST COMMON CAUSES FOR THE FAILURE OF CONCRETE RETAINING BLOCK WALLS

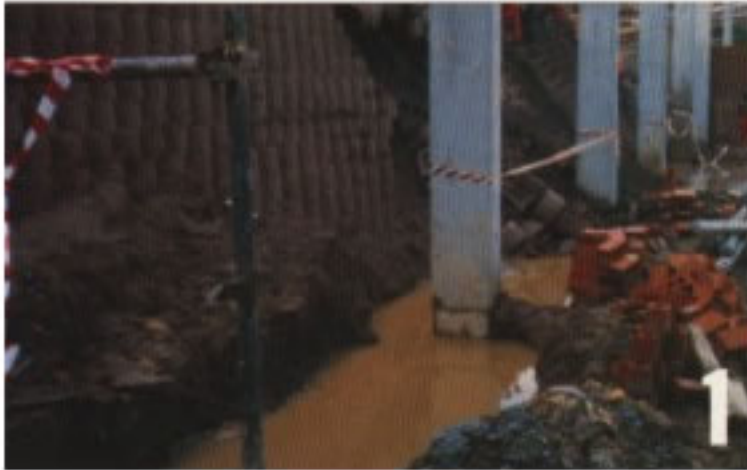
- 1 The wall featured in 1 was built 5° steeper than it should have been.
- The drainage system installed behind and above the wall was not adequate.
  - The cement stabilised backfill behind the wall was not properly mixed.
  - Trench excavations were carried out along the toe of the wall.
  - Limited bearing capacity and excessive settlement C.

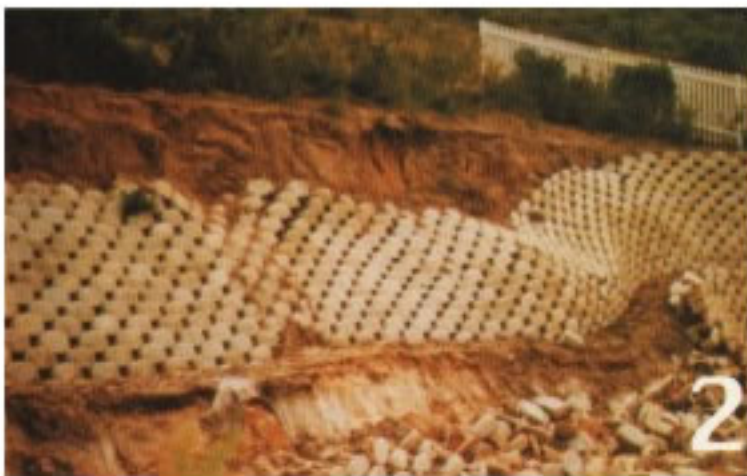
- 2 No stormwater drainage system installed above Wall 2.
- External stability was not taken into account (J)
  - Insufficient constructed mass (blocks too small).

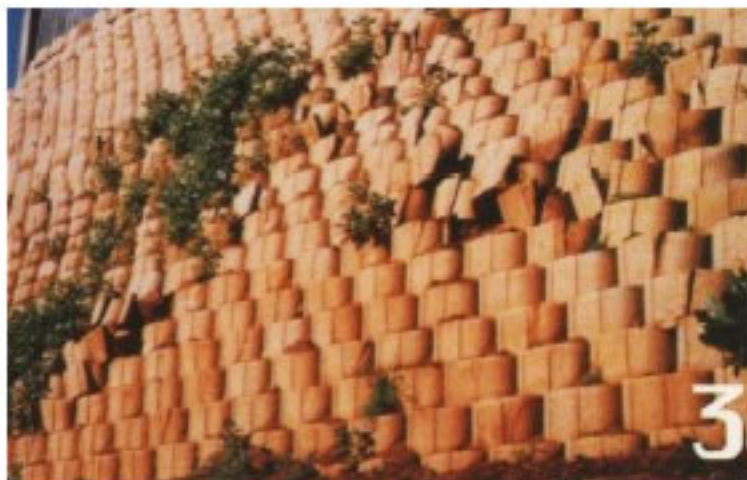
- 3 The drainage system installed behind and above Wall 3 was not adequate.
- Subsequently settlement of the backfill occurred.
  - Proper connection was not maintained between the blocks and reinforcing fabrics.
  - Bulging resulted (H)

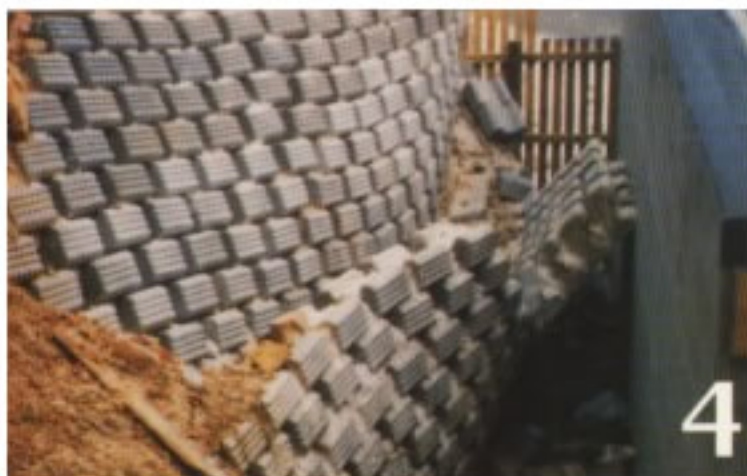
- 4 Wall 4 shows signs of inadequate cut-off drainage and incorrect stability calculations, with excessive settlement and limited bearing capacity in the top section C.
- The angle of construction in the bottom section of the wall is incorrect, resulting in overturning (B).

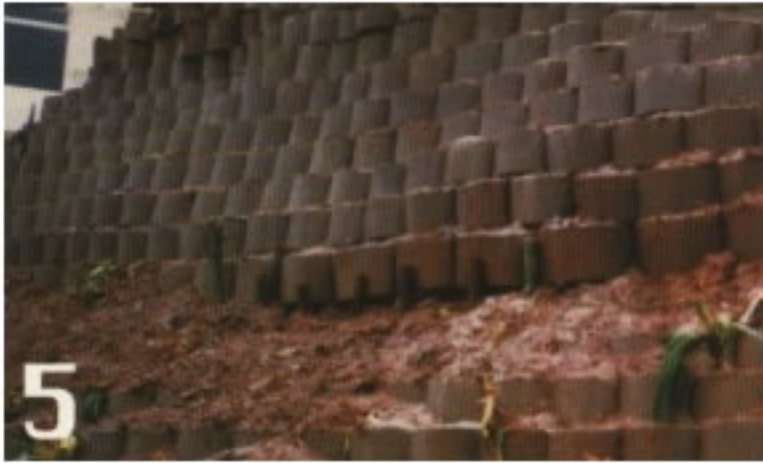
- 5 The drainage system behind and above the wall is not adequate.
- Saturated founding conditions were also a major factor.

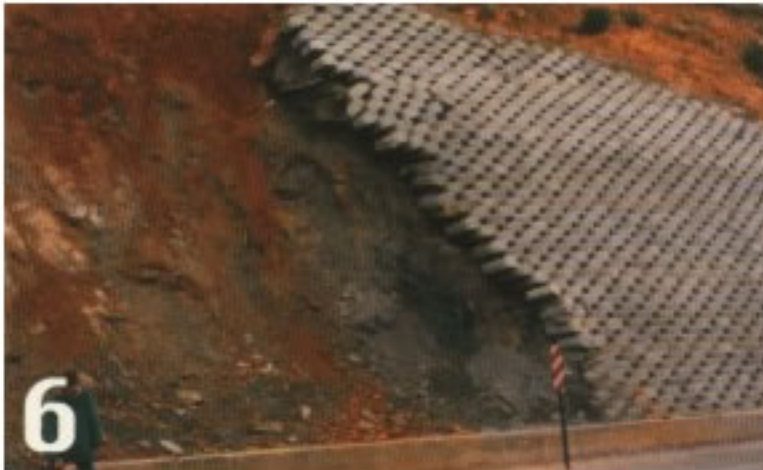
- 6 The 9 m high erosion control installation failed because of water seepage through the low strength, fractured and highly weathered rock which caused a deep seated failure of the slope.

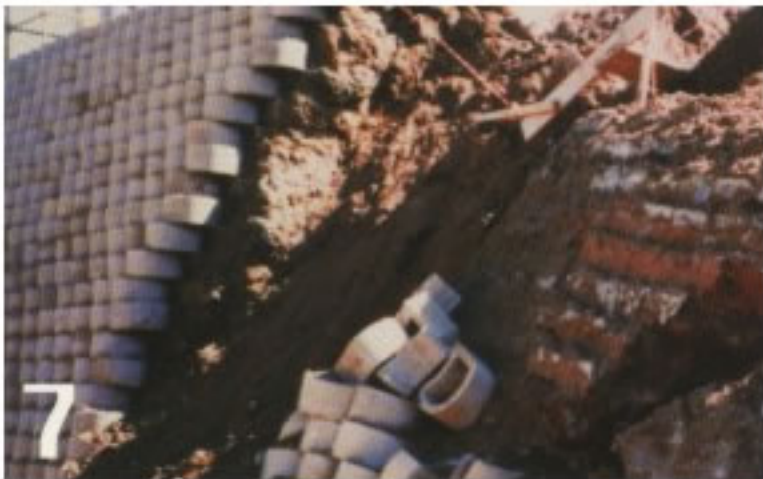
- 7 The design angle and the height of this wall are incorrect due to lack of professional input or supervision
- This resulted in horizontal movement, bulging and collapse.

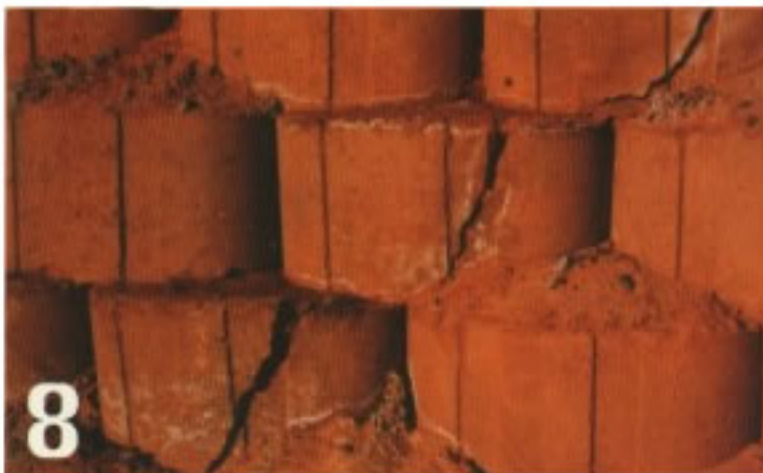
- 8 Isolated cracked blocks do not indicate imminent failure. However, cracks appearing in diagonal rows across the face of wall or closely spaced in adjacent units are definite signs for concern.
